A SYSTEMATIC APPROACH TO EVALUATING HISTORICAL WOOD WINDOWS FOR REPAIR AND RESTORATION

By Steven R. Marshall, RRC, CDT, LEED AP,
and Catherine Matathia, PE, LEED AP

This article is reprinted from the Proceedings of the 29th RCI International Convention and Trade Show in 2014 in Anaheim, California.

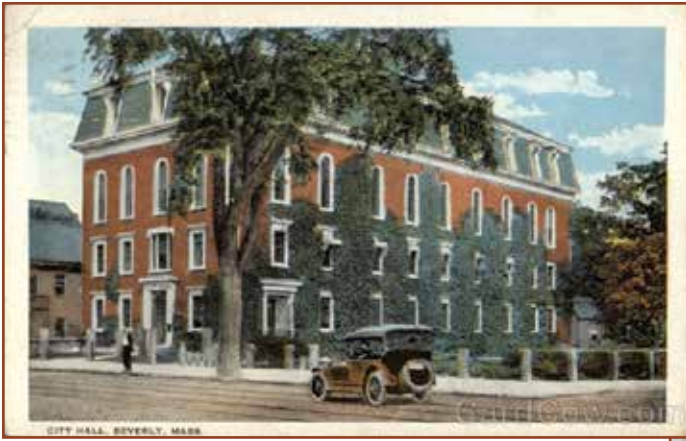
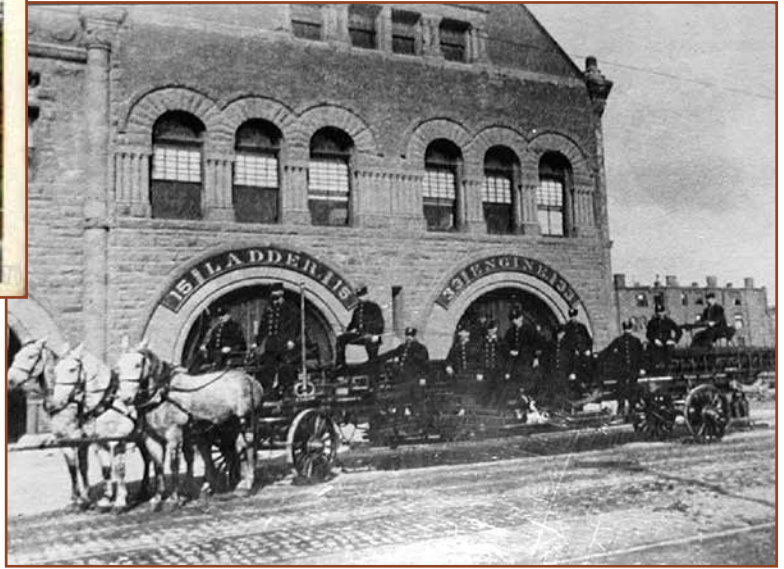
Photos 1 and 2 – An historical photo of the Boston Fire Station, Boston, MA (below) and an historical post card of the Beverly City Hall, Beverly, MA (left) helped identify the appropriate window configurations for these buildings.

See Photos 1 and 2.

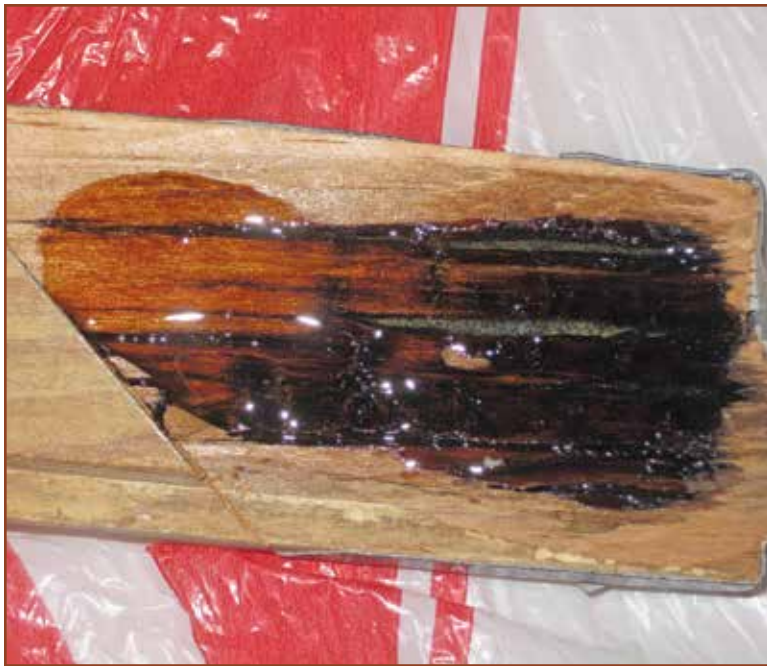
Photo 3 – Epoxy repair of checked wood with resin.

Epoxy repairs consist of using an epoxy resin or paste to fill in cracks, gauges, and rot (after removing the existing rotted wood) to stabilize the wood. Epoxy repairs are often required at sash corners where the joinery has failed. Epoxy repairs require significant preparation of the existing wood and may need several applications of epoxy to completely fill the damaged area. Epoxy requires time to set, and the repairs need to be sculpted and shaved to match the profile of the surrounding wood finishes.

to match the opening. The dutchman is set into the opening with a resin. Dutchman repairs are most suitable for large-area repairs. See *Photos 3 and 4*.

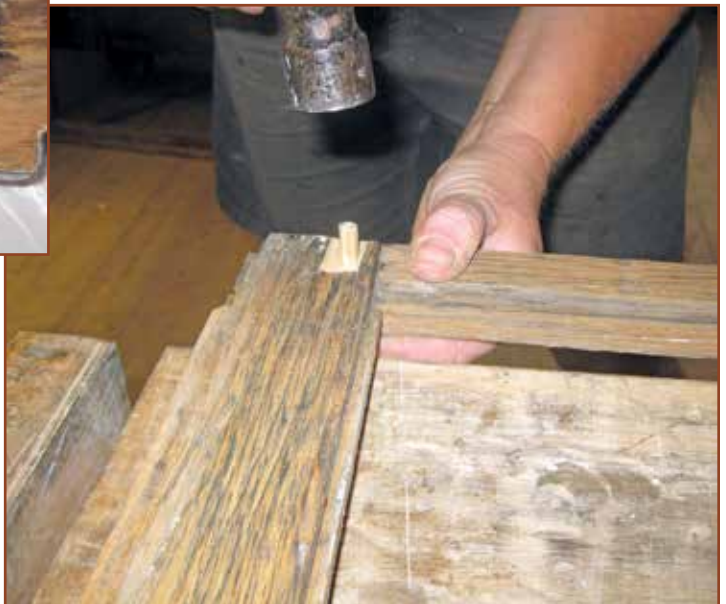
Photo 4 –Dutchman repair of wood sash corner.

Dutchman repairs involve repairing existing areas of rotted or missing wood with new wood. Ideally, the new wood should match the species of the original wood. If the species of the original wood cannot be matched, the new wood should be mahogany, cedar, or oak in order to be as similar as possible to the density of the original old-growth wood. With a dutchman repair, the area of rotted wood is cut out, and the replacement wood (dutchman) cut
