# SLATE ROOF EVALUATIONS AND DESIGN CONSIDERATIONS

By  
Christopher  
Musorofiti, RRC

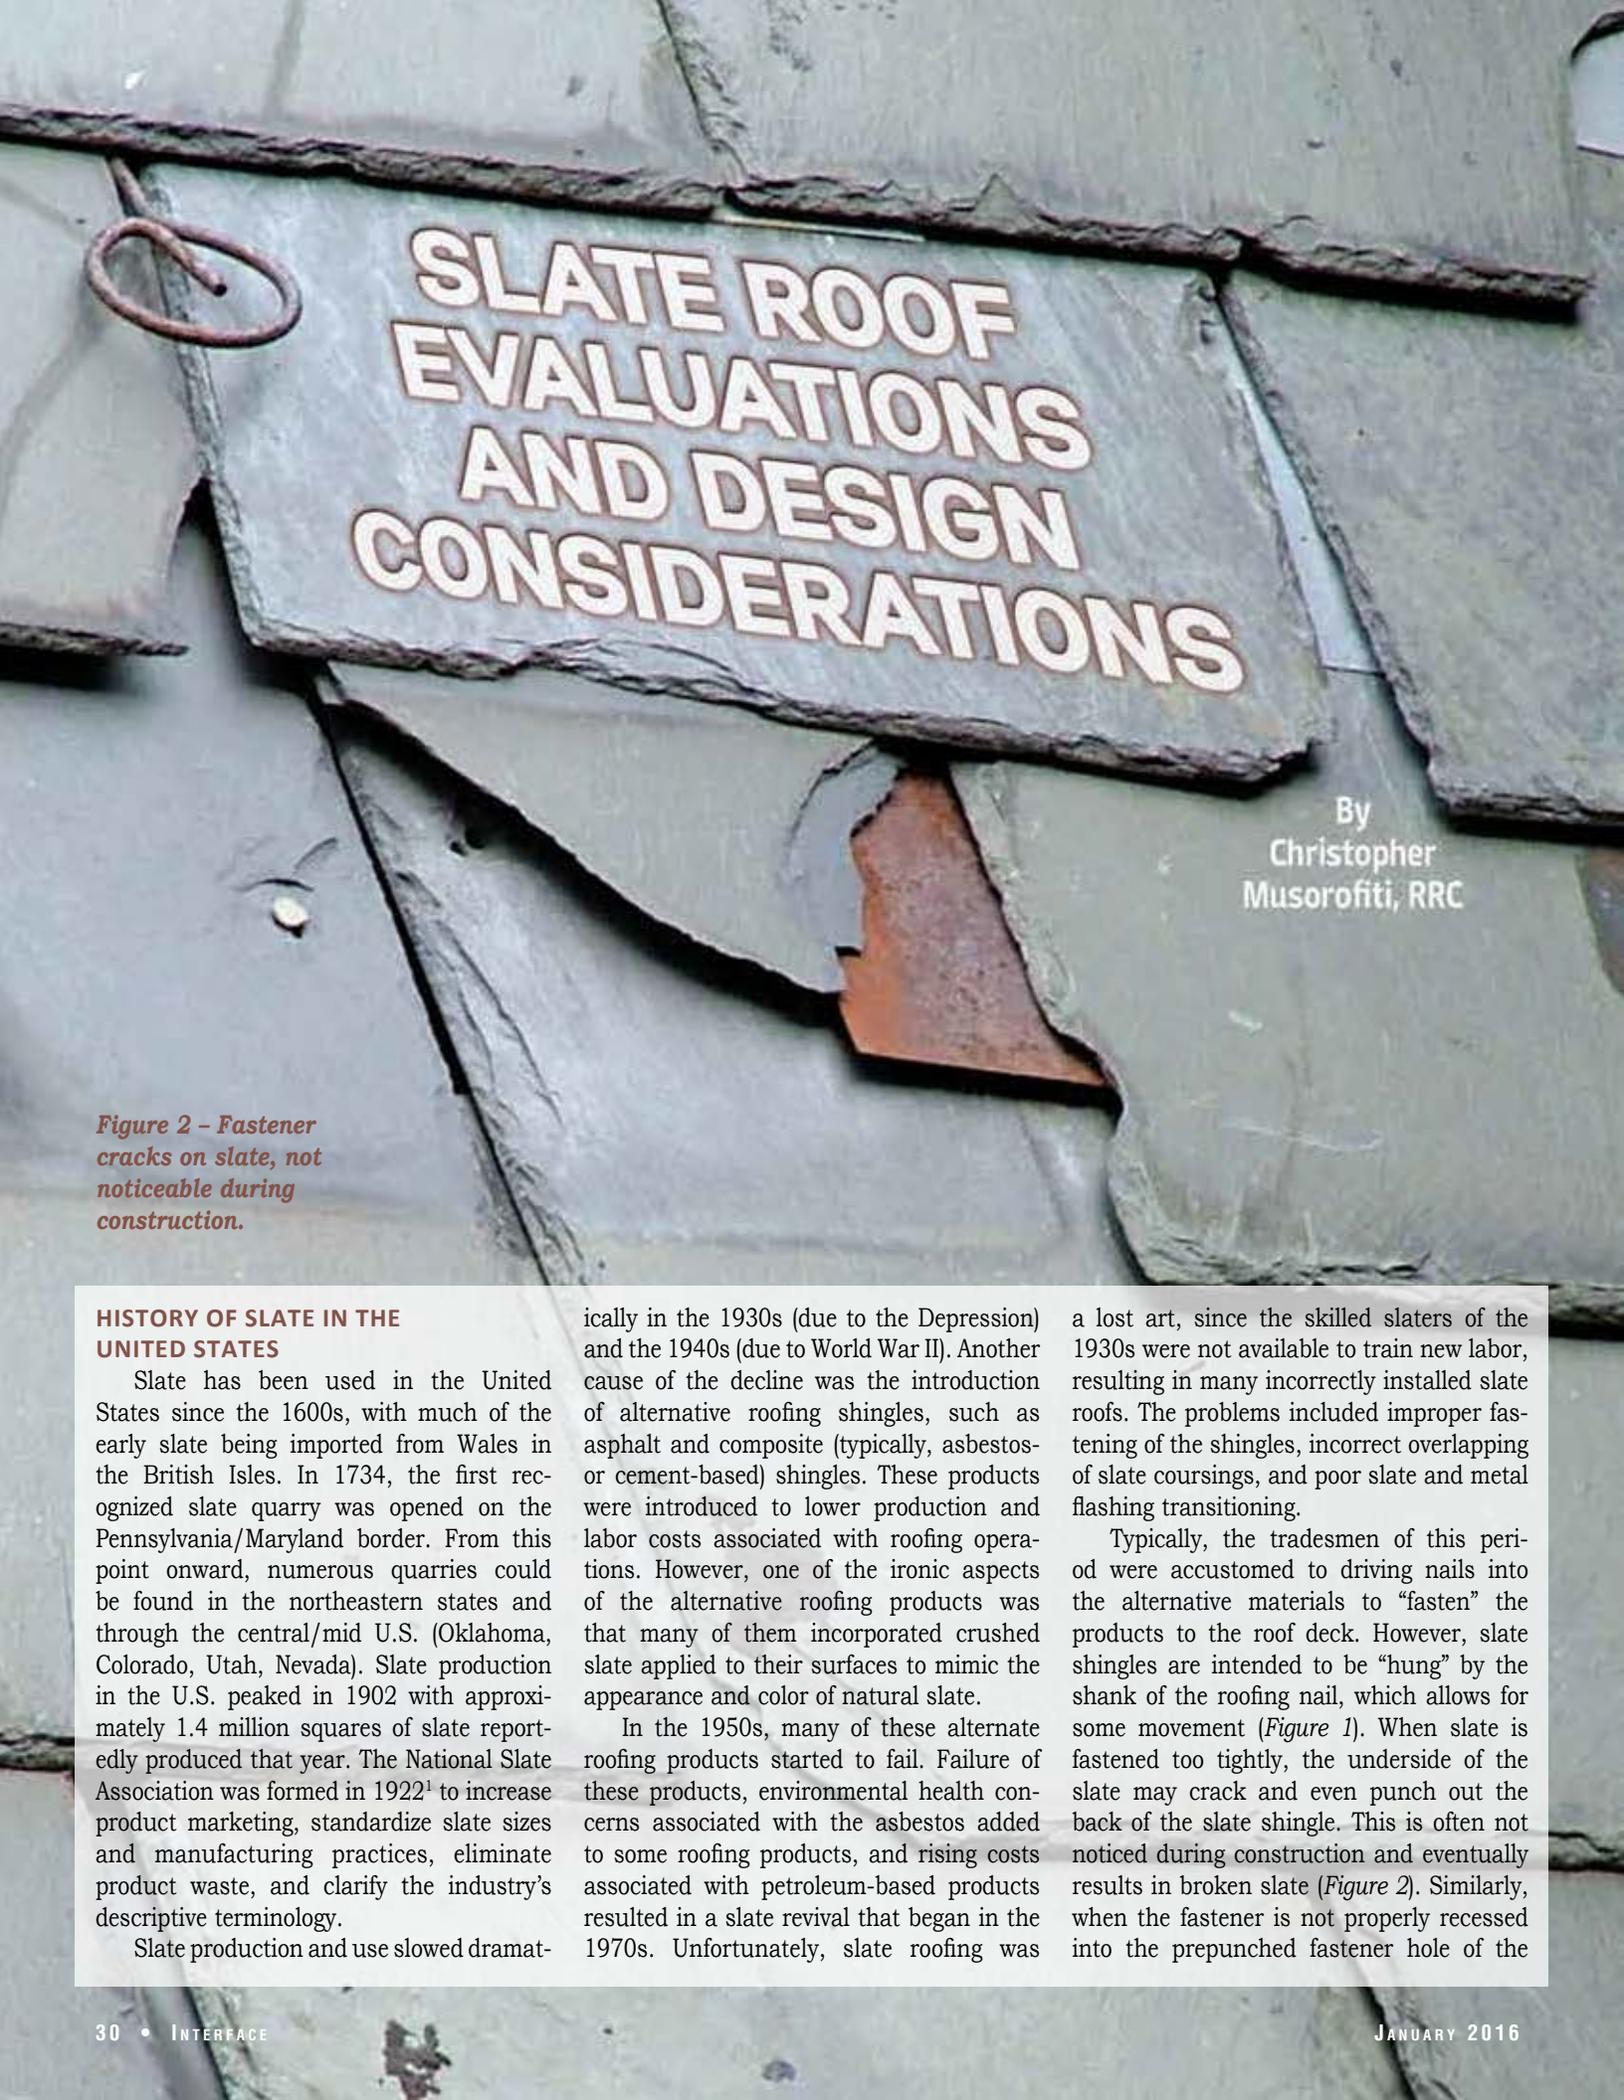
*Figure 2 - Fastener cracks on slate, not noticeable during construction.*

Typically, the tradesmen of this period were accustomed to driving nails into the alternative materials to "fasten" the products to the roof deck. However, slate shingles are intended to be "hung" by the shank of the roofing nail, which allows for some movement (*Figure 1*). When slate is fastened too tightly, the underside of the slate may crack and even punch out the back of the slate shingle. This is often not noticed during construction and eventually results in broken slate (*Figure 2*). Similarly, when the fastener is not properly recessed into the prepunched fastener hole of the

slate, it can protrude into the underside of the upper course of slate and will fracture/crack as a result of applied loading (snow or trafficking of the roof).

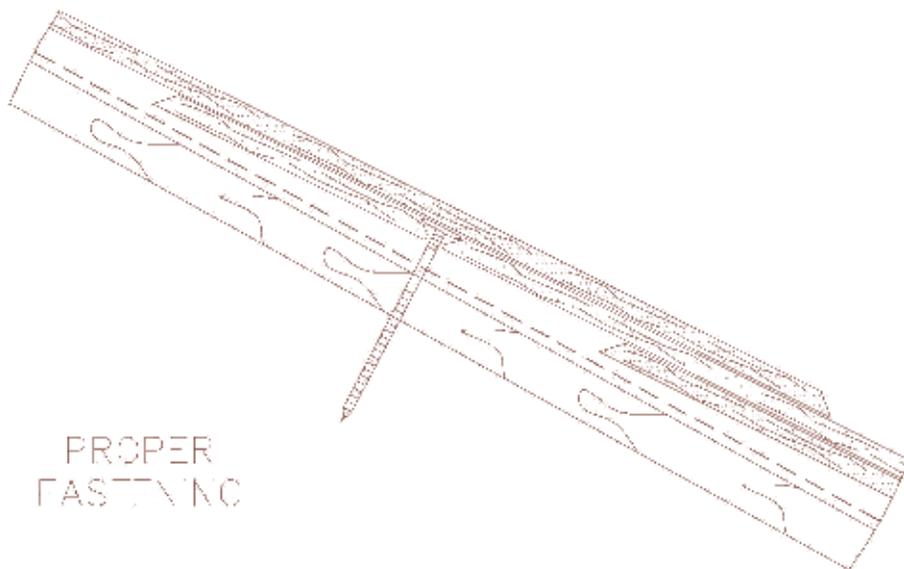
Figure 1 – Fastener sits flush with the top surface of the shingle, within the punched hole.

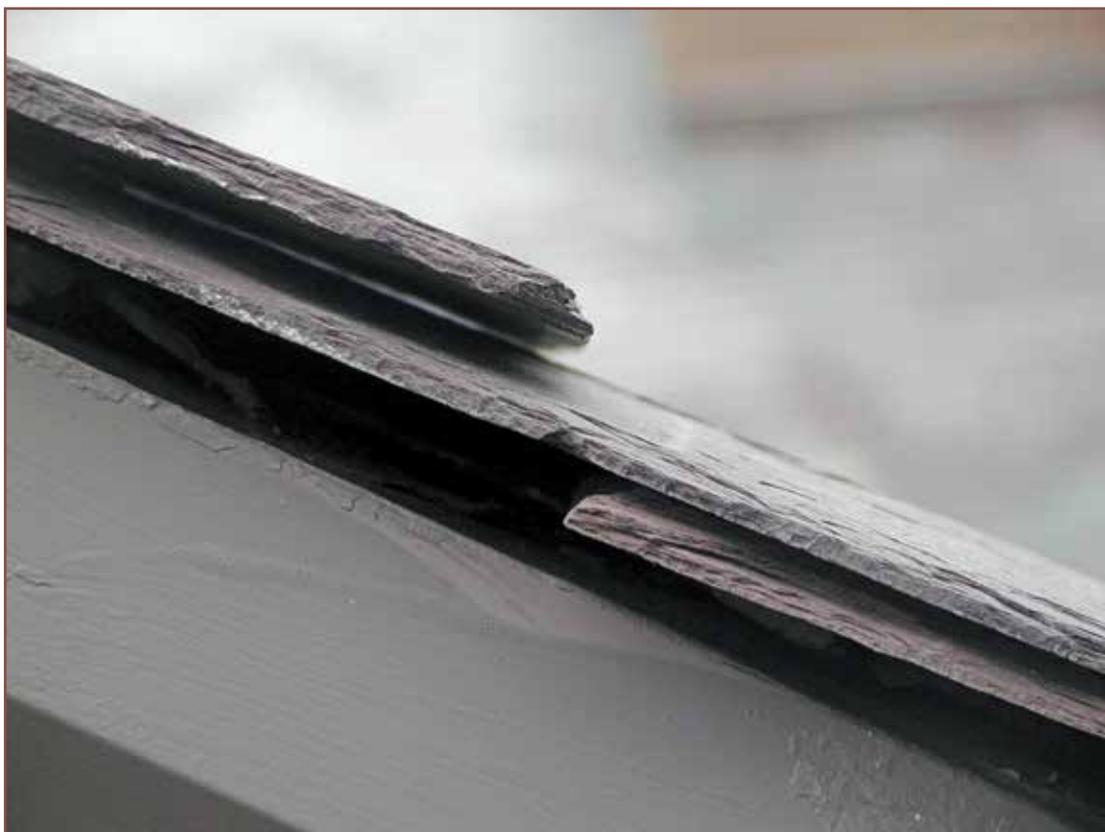
Figure 3 – Improper head laps.

Improper overlapping and head laps of the shingles (Figure 3) also posed a problem, as these conditions can allow water infiltration into the nail holes or openings between the shingle coursing, potentially deteriorating the roof decking and allowing moisture infiltration to the interior.

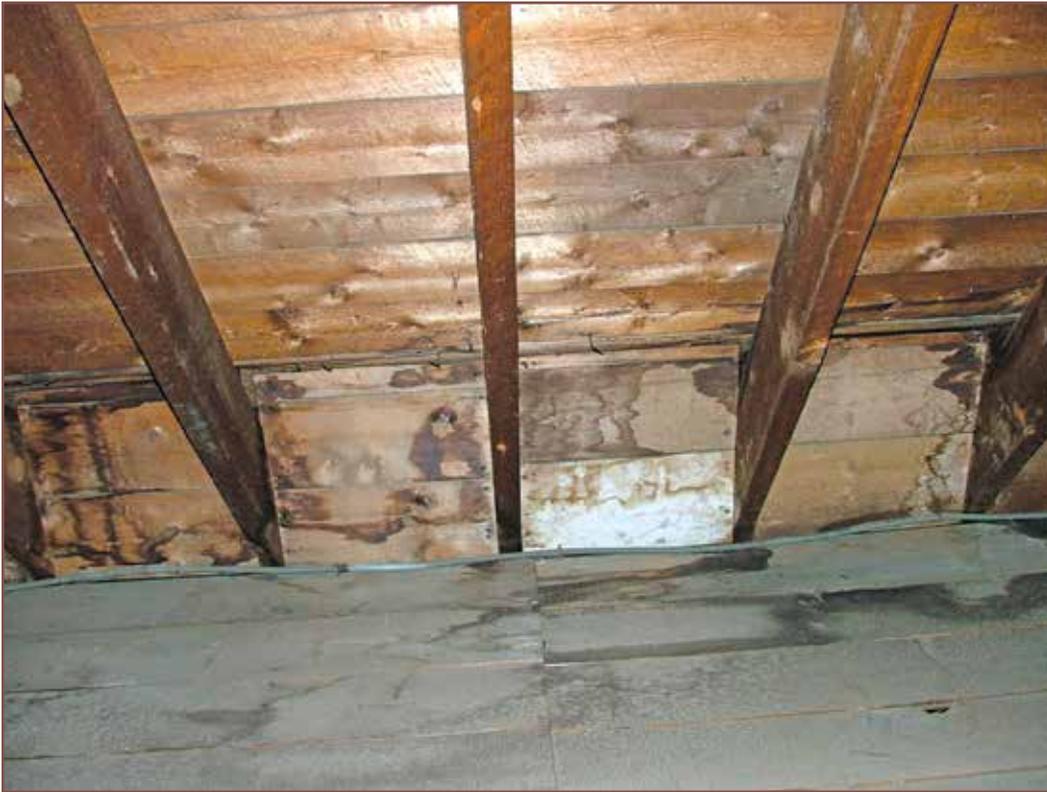
Figure 4 – Staining under roof deck and on floor.

- Staining under the roof deck or on the floor
- Efflorescent staining on the underside of a concrete deck
- Rust staining of structural steel pur-

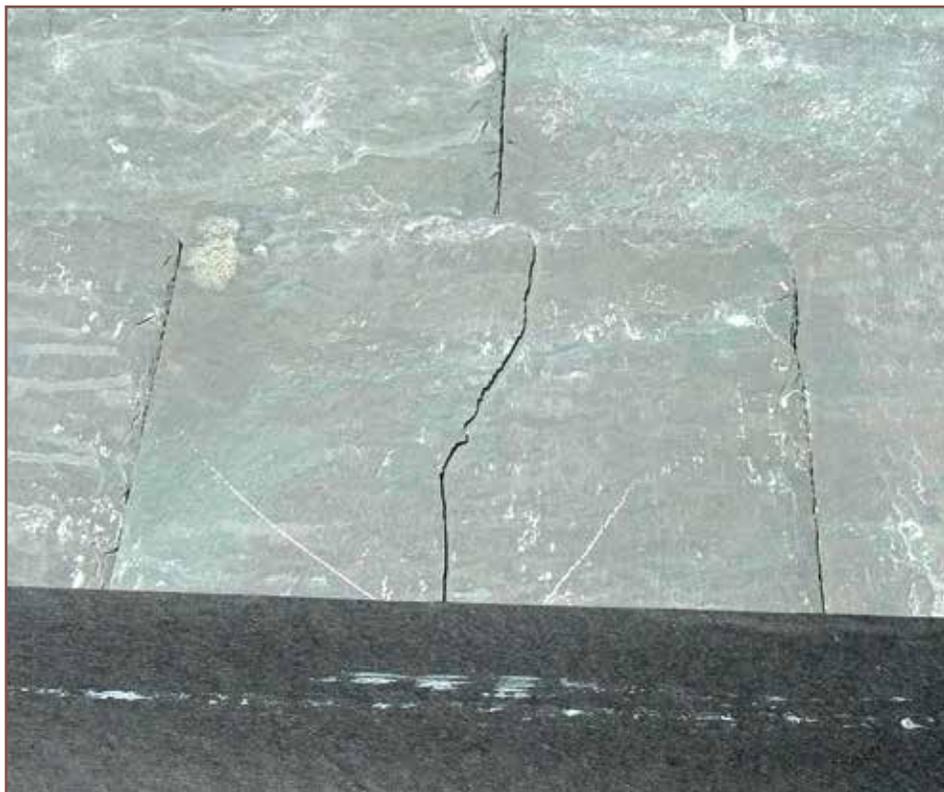
Figure 5 – Cracked slate.

- Cracked slate, either vertically or horizontally (*Figure 5*)
- Broken corners that exceed a 1-in by 1-in-square dimension
- Sheet metal repair materials under the slate shingles
- Insufficient slate overlaps
- Holes, results of iron deposits, or incorrectly installed shingle units
- Delamination of slate (typically a result of mineral impurities that react with water and form gypsum within the cleavage planes)
- Backed out or protruding fasteners
- Sealant repairs over defective slate

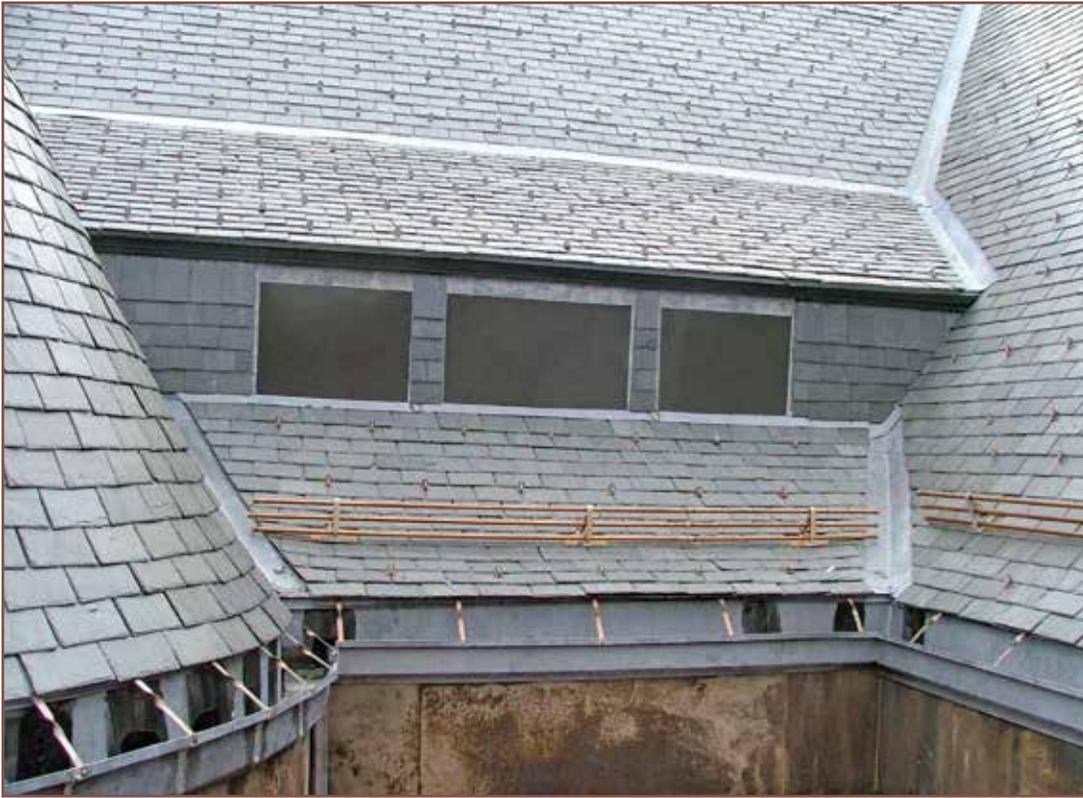
Figure 6 – Snow guard installation.

building codes for storm drainage. Snow guard types and placements (Figure 6) are critical to address snow slide to other roof areas and site features such as walkways, parking areas, and access locations.
