Avoiding Air Barrier Pitfalls

When sub-trade activities are not in sync with air barrier requirements, installation can go poorly.

By Brian H. Neely, AIA, CDT, CBST, and Robert F. Mimmo, CBST, Gale Associates Inc.

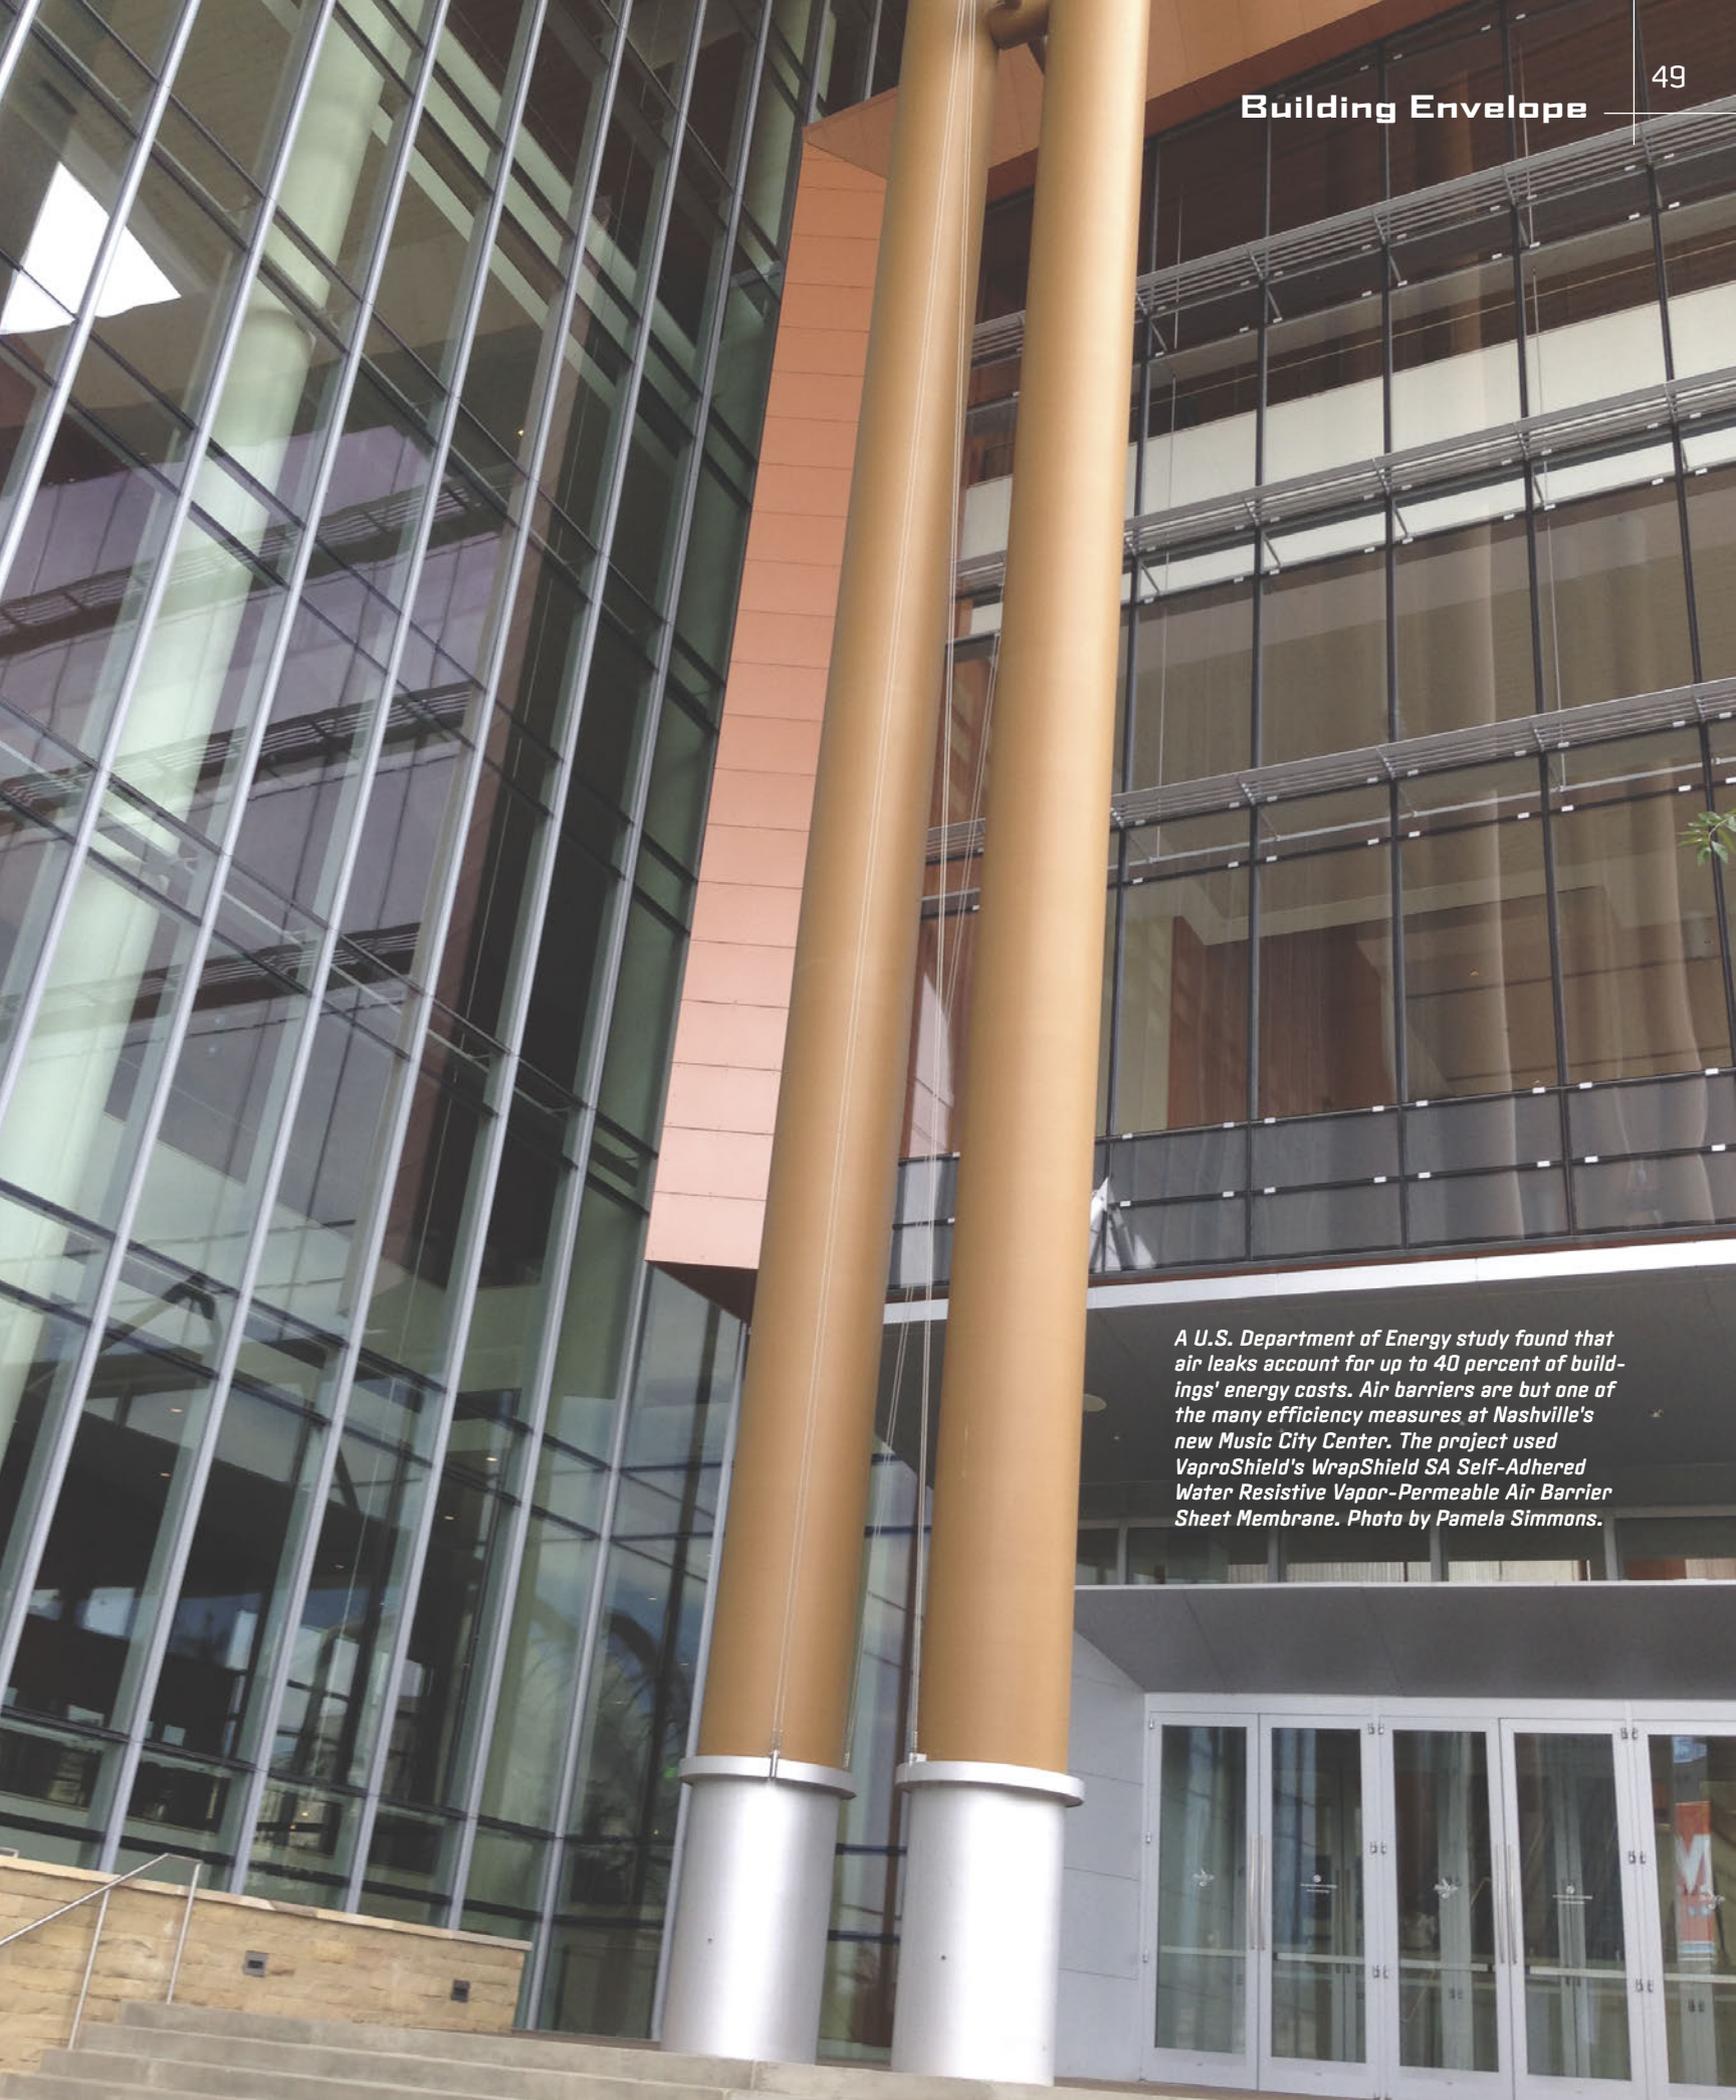
A U.S. Department of Energy study found that air leaks account for up to 40 percent of buildings' energy costs. Air barriers are but one of the many efficiency measures at Nashville's new Music City Center. The project used VaproShield's WrapShield SA Self-Adhered Water Resistive Vapor-Permeable Air Barrier Sheet Membrane. Photo by Pamela Simmons.

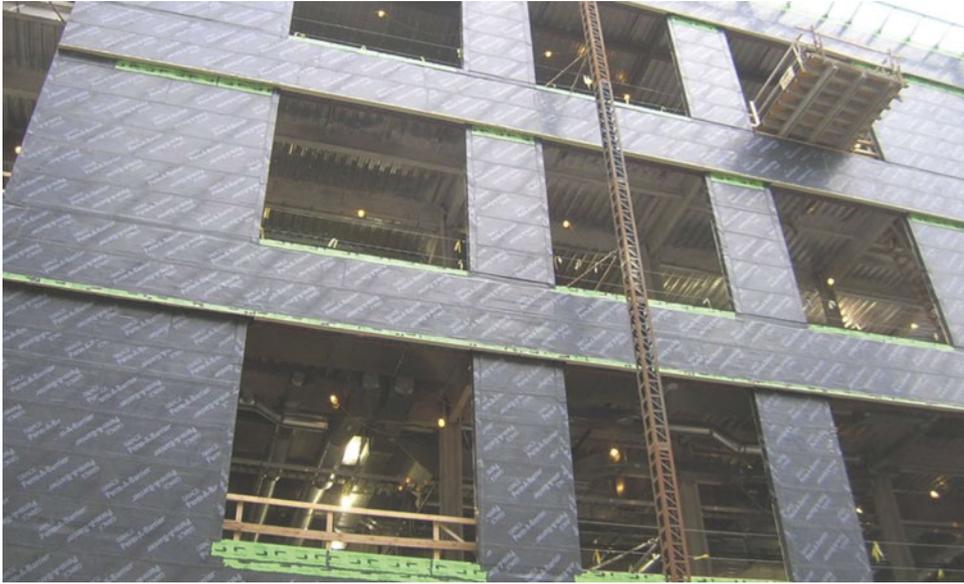
As shown at a courthouse in Massachusetts, a well-prepared substrate provides a smooth surface for the air barrier installation. Photos courtesy of Gale Associates Inc.

crete masonry unit and gypsum wall sheathing over metal-stud framing, a self-adhering air/vapor barrier membrane, and rigid insulation and brick masonry veneer. Proper substrate construction and preparation resulted in a firmly adhered air/vapor

barrier membrane that was free of defects such as wrinkles, blisters, fish mouths and delamination. (See photo top of page 50.)

The air barrier contractor reviewed each substrate prior to installation of the air barrier and required that all deficiencies be corrected before the air barrier was installed. The roof system was installed prior to the air/vapor barrier membrane wall installation in each area of the building, keeping the substrates dry.

Through his quality program, the contractor reviewed each wall area and installed the air/vapor barrier membrane only if the substrate was free of visible defects and visibly dry. This project was well-documented and well-coordinated and the installers were skilled. Hence, the air barrier installation was smooth and successful.

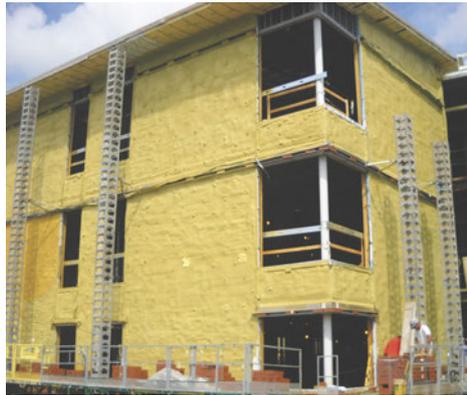
Top, at a Rhode Island middle school, membrane air barrier extends from the roof across the soffit and ties in the spray foam, acting as the air barrier on the vertical walls.

In the case of this middle school, the exterior walls consisted of a steel-framed structure, metal-stud framing and gypsum wall sheathing. A self-adhering sheet transition membrane was installed at changes in substrate plane and around wall penetrations, with a spray-applied polyurethane foam insulating air/vapor barrier applied to the gypsum prior to construction of the outer brick masonry veneer. (See photos, page 50.)

ported and properly prepared to receive the air barrier membrane. This provided a solid backing for installing transition membranes between the roof and wall assemblies and at wall penetrations.

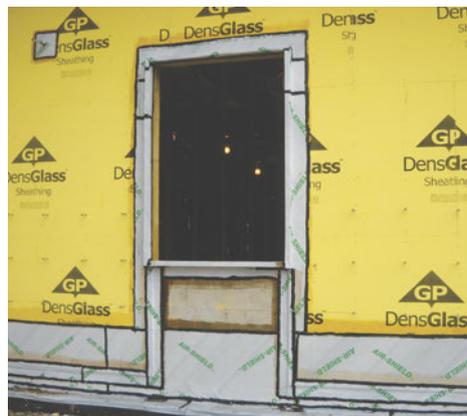
Bottom, membrane treatment of openings, penetrations and change in materials in preparation for spray foam installation at the middle school.

The subcontractor had a quality control plan whereby general contractor personnel immediately corrected substrate deficiencies before the spray-polyurethane foam air barrier was applied. The general contractor responded to deficiencies raised and coordinated subcontractors, resulting in a properly installed air/vapor barrier membrane.

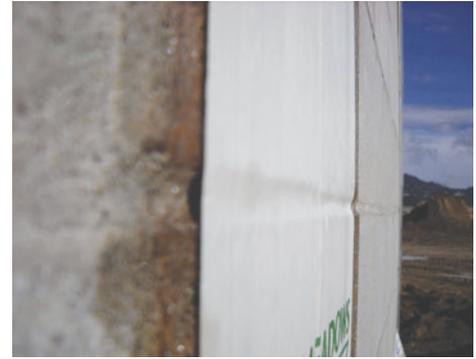
Air barrier membrane bridging concave mortar joints at the North Carolina elementary school.

The self-adhering transition membranes bridged the concave tooled concrete masonry unit joints. This condition was widespread, including at control joints and around windows. Mortar joints must be struck flush so that the air barrier will adhere smoothly.

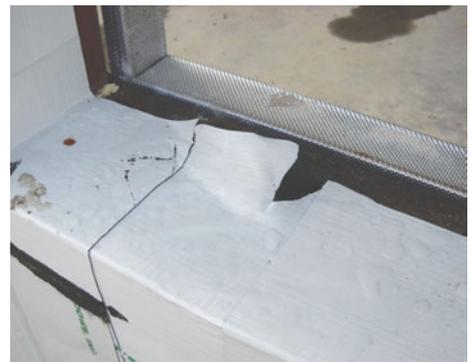
At the North Carolina elementary school, loose and unadhered air barrier membrane was observed at the windowsill, over moist substrates.

Transition membranes at window headers and sills were unprotected from the weather, resulting in widespread delamination. These locations had to be cut out and replaced.

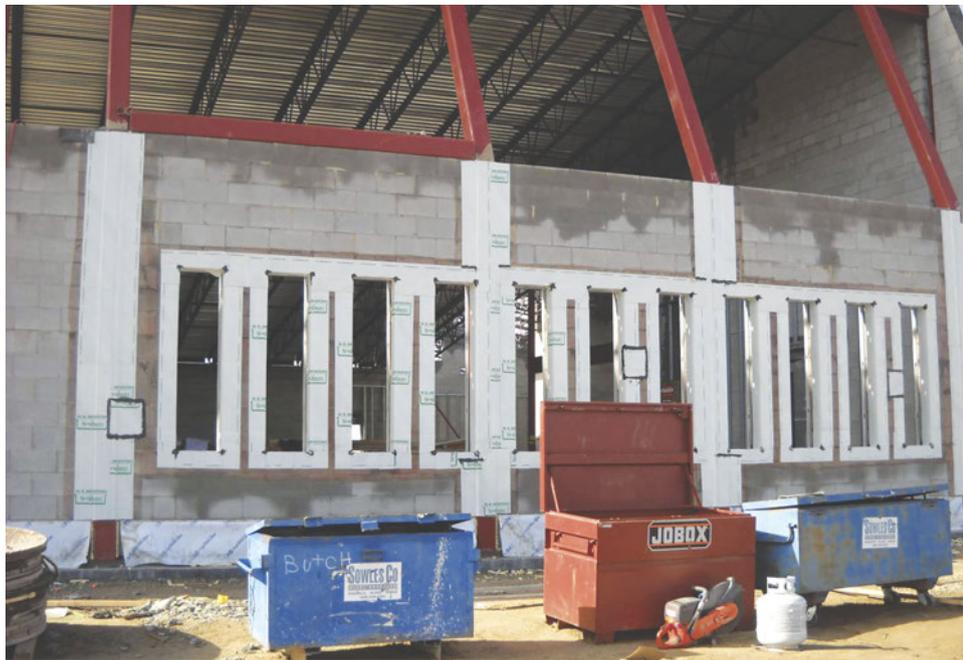
At a North Carolina elementary school, air barrier membrane is installed over an unprotected wall and damp substrates. While the membrane appears to be well detailed, the membrane was loose and not fully adhered.

The wall design for this elementary school consisted of a steel-frame structure with concrete masonry unit backup walls, a fluid-applied air barrier membrane, rigid insulation and an exterior brick masonry veneer. The general contractor pushed the subcontractors to install the air barriers so that wall cladding installation could begin. They installed the air barrier membrane while the exterior backup walls were exposed to the elements, including rain and snow. Because the roof system wasn't installed, the concrete masonry unit backup wall became saturated. That degraded adhesion of the air barrier, causing the membrane to flap in the wind.

When these items were reviewed, the air barrier installer indicated they were rushed because the general contractor was anxious to install the insulation and brick veneer. Consequently, the fluid-applied air/vapor barrier was applied regardless of weather and substrate conditions.

Disregard for good construction practice caused widespread membrane deficiencies in the field of the wall. These deficiencies included blisters that contained moisture, as well as several areas where material ran off onto interior walls. The fluid-applied air/vapor barrier membrane did not have a chance to adequately cure, causing widespread blistering.

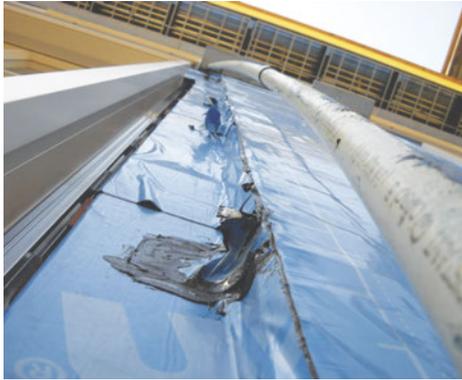
Poor substrate installation and the absence of a quality installer at the North Carolina science building resulted in a self-adhered air barrier membrane demonstrating wrinkles and fish mouth seams.

The representative should have been more aware of the poor installation quality of the product. Poor substrate installation and the absence of a quality installer resulted in installation deficiencies that included inconsistent application of substrate primer; tented, wrinkled and bridged membrane; delaminated overlaps; and the absence of termination mastics where typically required by the manufacturer.

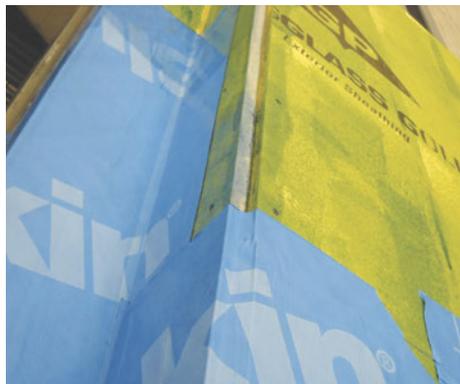
At the North Carolina science building, air barrier membrane spans untreated gypsum sheathing boards, which do not abut at the outside corners.

The project seemed to be well-run and the gypsum wall sheathing substrate appeared to be in good condition to receive the air/vapor barrier membrane. However, the sheathing exhibited gaps at changes in substrate plane, such as outside corners and around windows. Transitions between different substrates (i.e., gypsum wall sheathing and steel) weren't properly prepared to receive the air/vapor barrier membrane. That caused the membrane to become unsupported at the transitions.

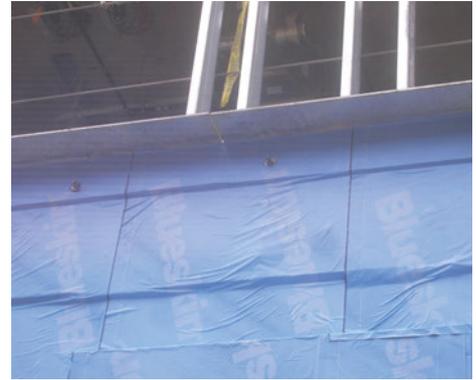
The air barrier membrane is wrinkled, tented over projections in the substrate and spanning over substrate changes in plane at the North Carolina science building.
